ArtikControl™

WIC / WIF

Graph Analysis Manual

Artik Control

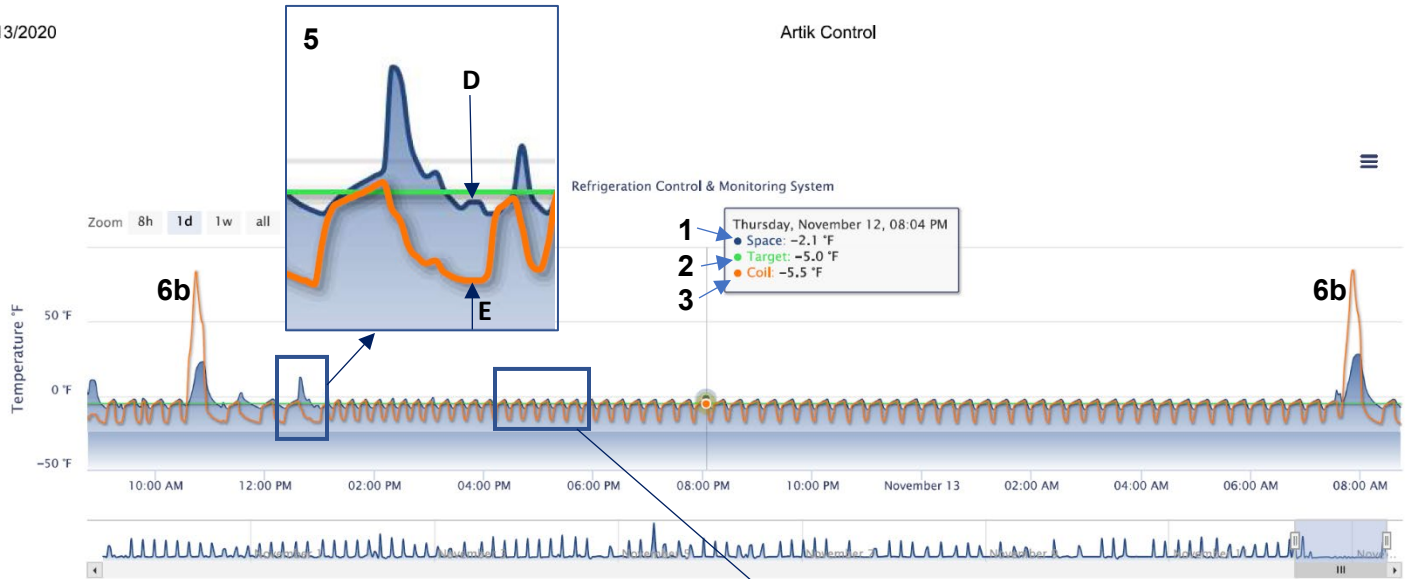
What can we see looking at the Graph?

1. Space Temperature
2. Coil Temperature
3. Target Temperature
4. Compressor Cycles
 - a. One Compressor Cycles is denoted by the segment labeled 'A'. It is the time from when the Compressor Turns 'ON' through the Compressor 'OFF' cycle.

- b. Compressor 'OFF' Time – Denoted by 'B'
 - c. Compressor 'ON' Time – Denoted by 'C'
5. Delta T (Temperature Difference between Space and Coil Temperatures)

- a. You can place the Mouse over an area on the Main Graph and it will show the Space Temp and the Coil Temp. You subtract the Coil Temperature from the Space Temperature to find the Delta T. If the Delta T is greater than 20 degrees, this can indicate a possible evaporator icing up. Temperature difference between 'D'-'E'.

6. Defrost
 - a. Temperature or Time Termination – This Defrost has Temperature Terminated.
 - b. Time between Defrost Cycles – 10am to 8am the following day (22 hrs. Defrost Cycle)

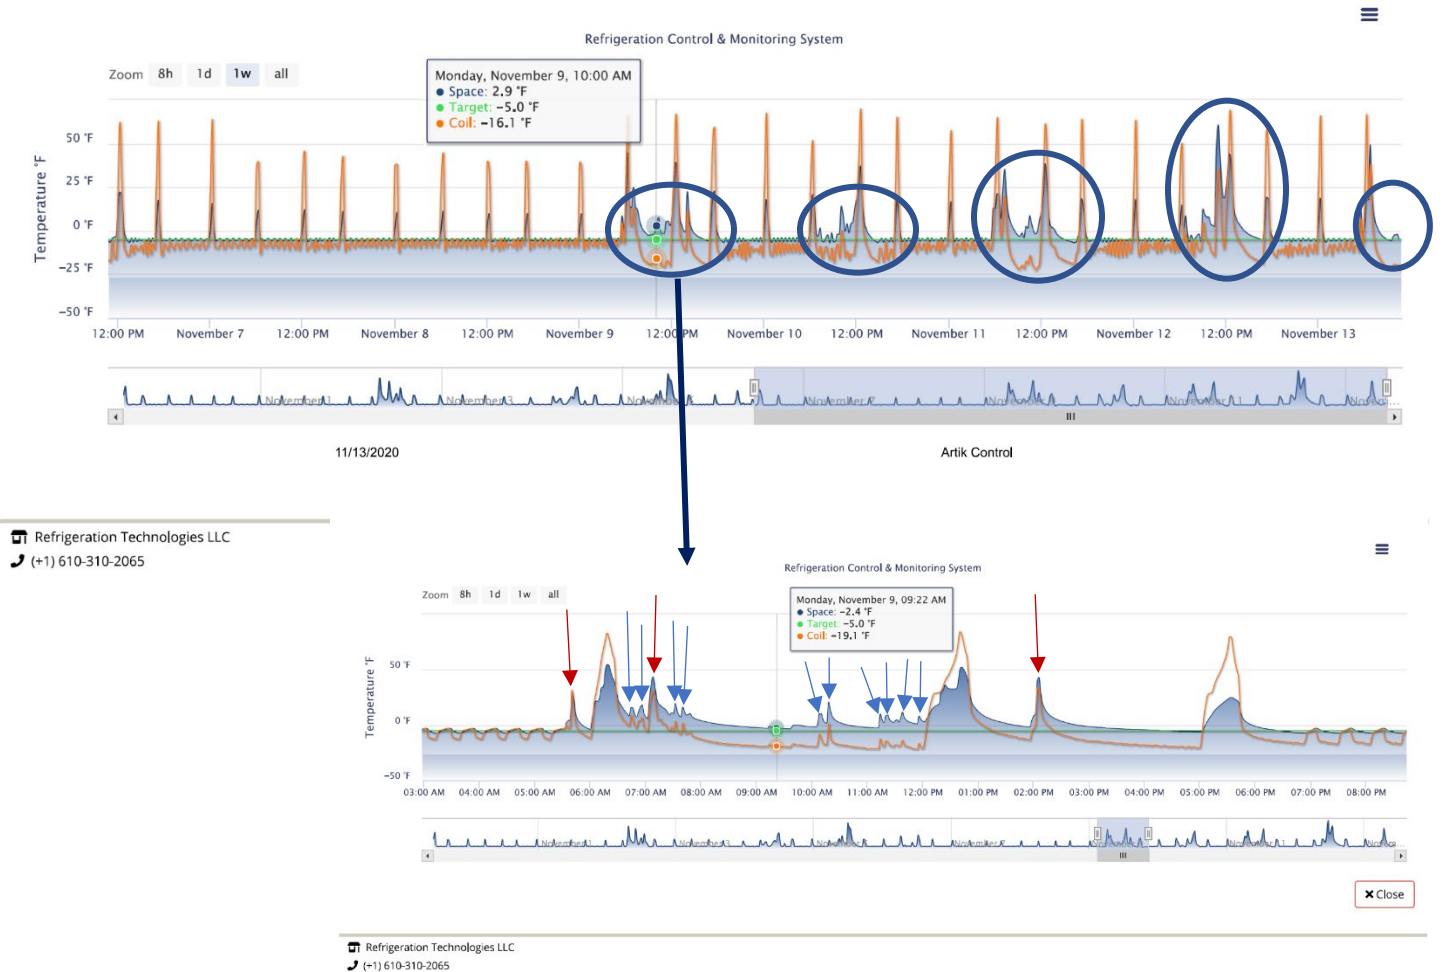
Behavioral Issues

From the Areas you see Circled, the Door is being left open causing warm air to enter the Freezer space.

Blue Arrows indicate when the door was opened. RED Arrows indicate when the door is open and left open for an extended period. With the kitchen being in operation there is an increase amount of moisture in the air, this moist air attaches to the coil causing the coil to ice up. The icing of the coil reduces the efficiency of the Evaporator Unit, causing the system to take longer to cool the space back down to the Target temperature.

You can see the Space Temperature is -2.4°F and the Coil Temperature is -19.1°F . This gives us a Delta T (ΔT) of 16.7°F .

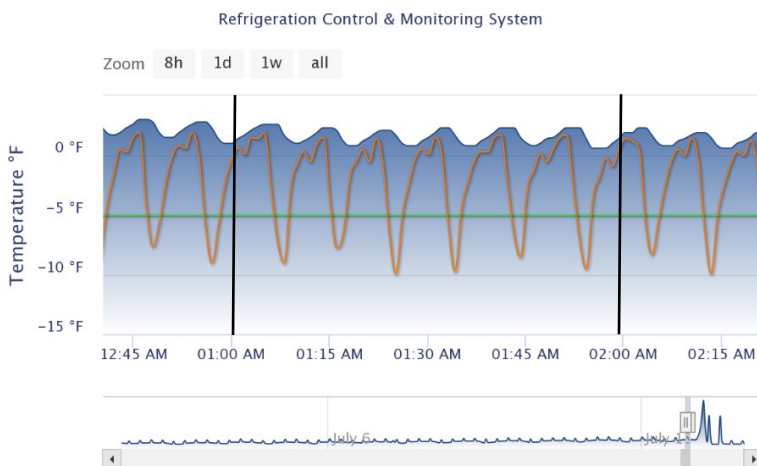
Below is an example of a Before and After graph showing compressor cycles. You will notice that in the before graph the compressor is running about 6 times an hour to maintain the Walk-in Freezer box temperature. After the Coil was cleaned the compressor is running about 4 times an hour. That would roughly equate to a reduction in compressor cycles of over 48 less compressor cycles per day for this Walk-in Freezer. In a year that is 17,520 less compressor cycles.

Before the Condenser Coils were cleaned.

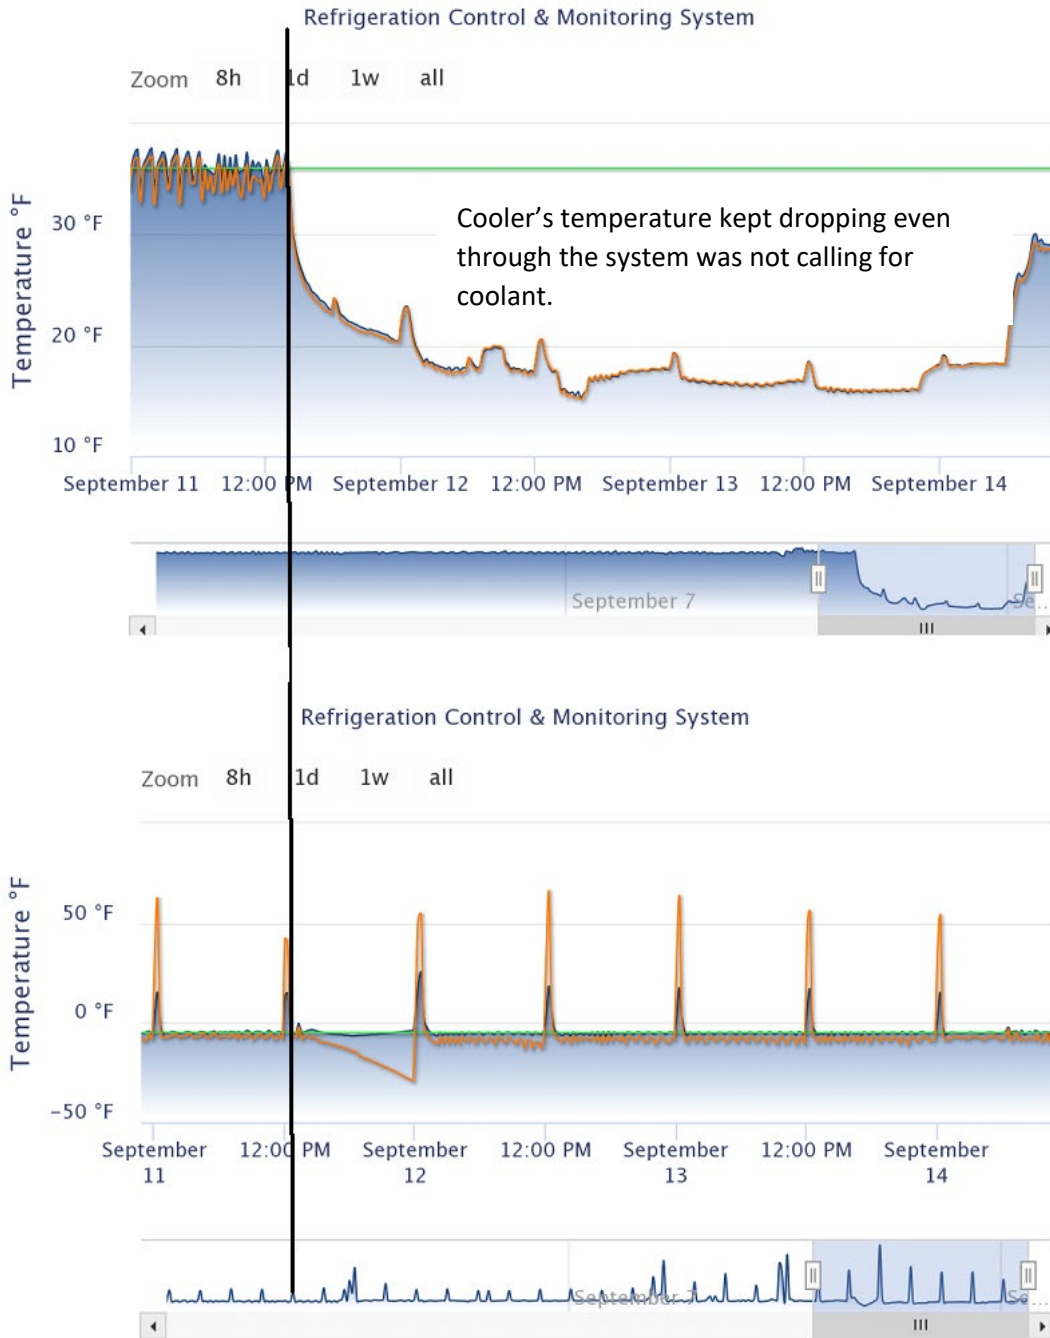
Freezer Door left Open into Cooler Unit

The Freezer is accessed through the Cooler. The Freezer door was left open about 2 feet. This caused the coolers temperature to continue to go below the Set-point, while the Freezer Condenser continued to run trying to keep the freezer at it's set-point.
